# HS2

# Summary assessment of ground conditions for Whitmore Heath Tunnel

Document no.: C861-ARP-GT-REP-WS06-000001

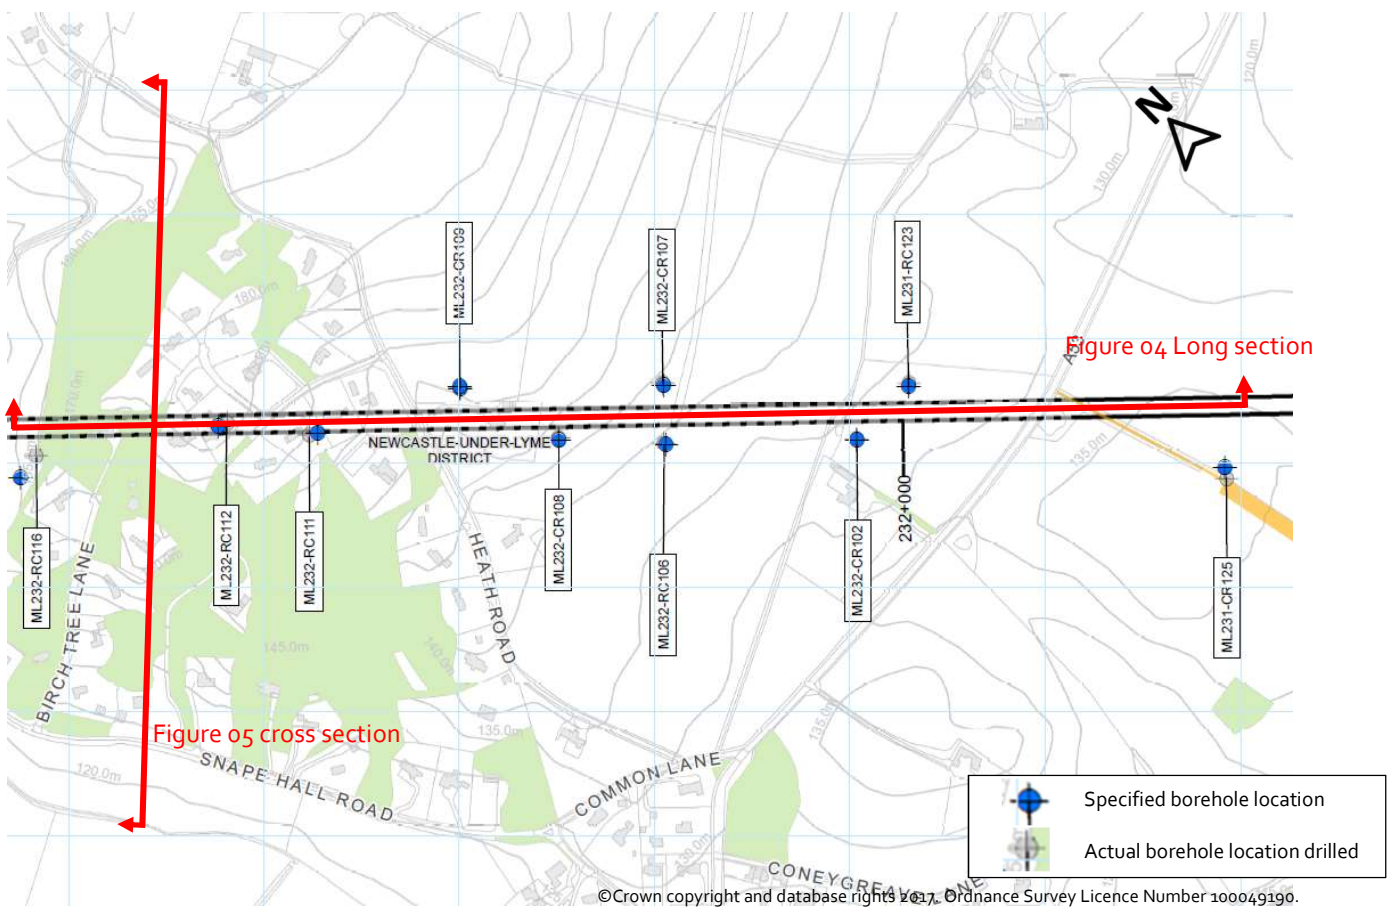
Figure 1 Borehole Location Plan and location of cross sections

- 4.1.1 Ground Investigation has been completed at Whitmore Heath with ten boreholes been completed and logged. The depths of these boreholes range from 43 m to 85 m. The approximate positions are shown on the location plan in Figure 1 and includes the borehole references.

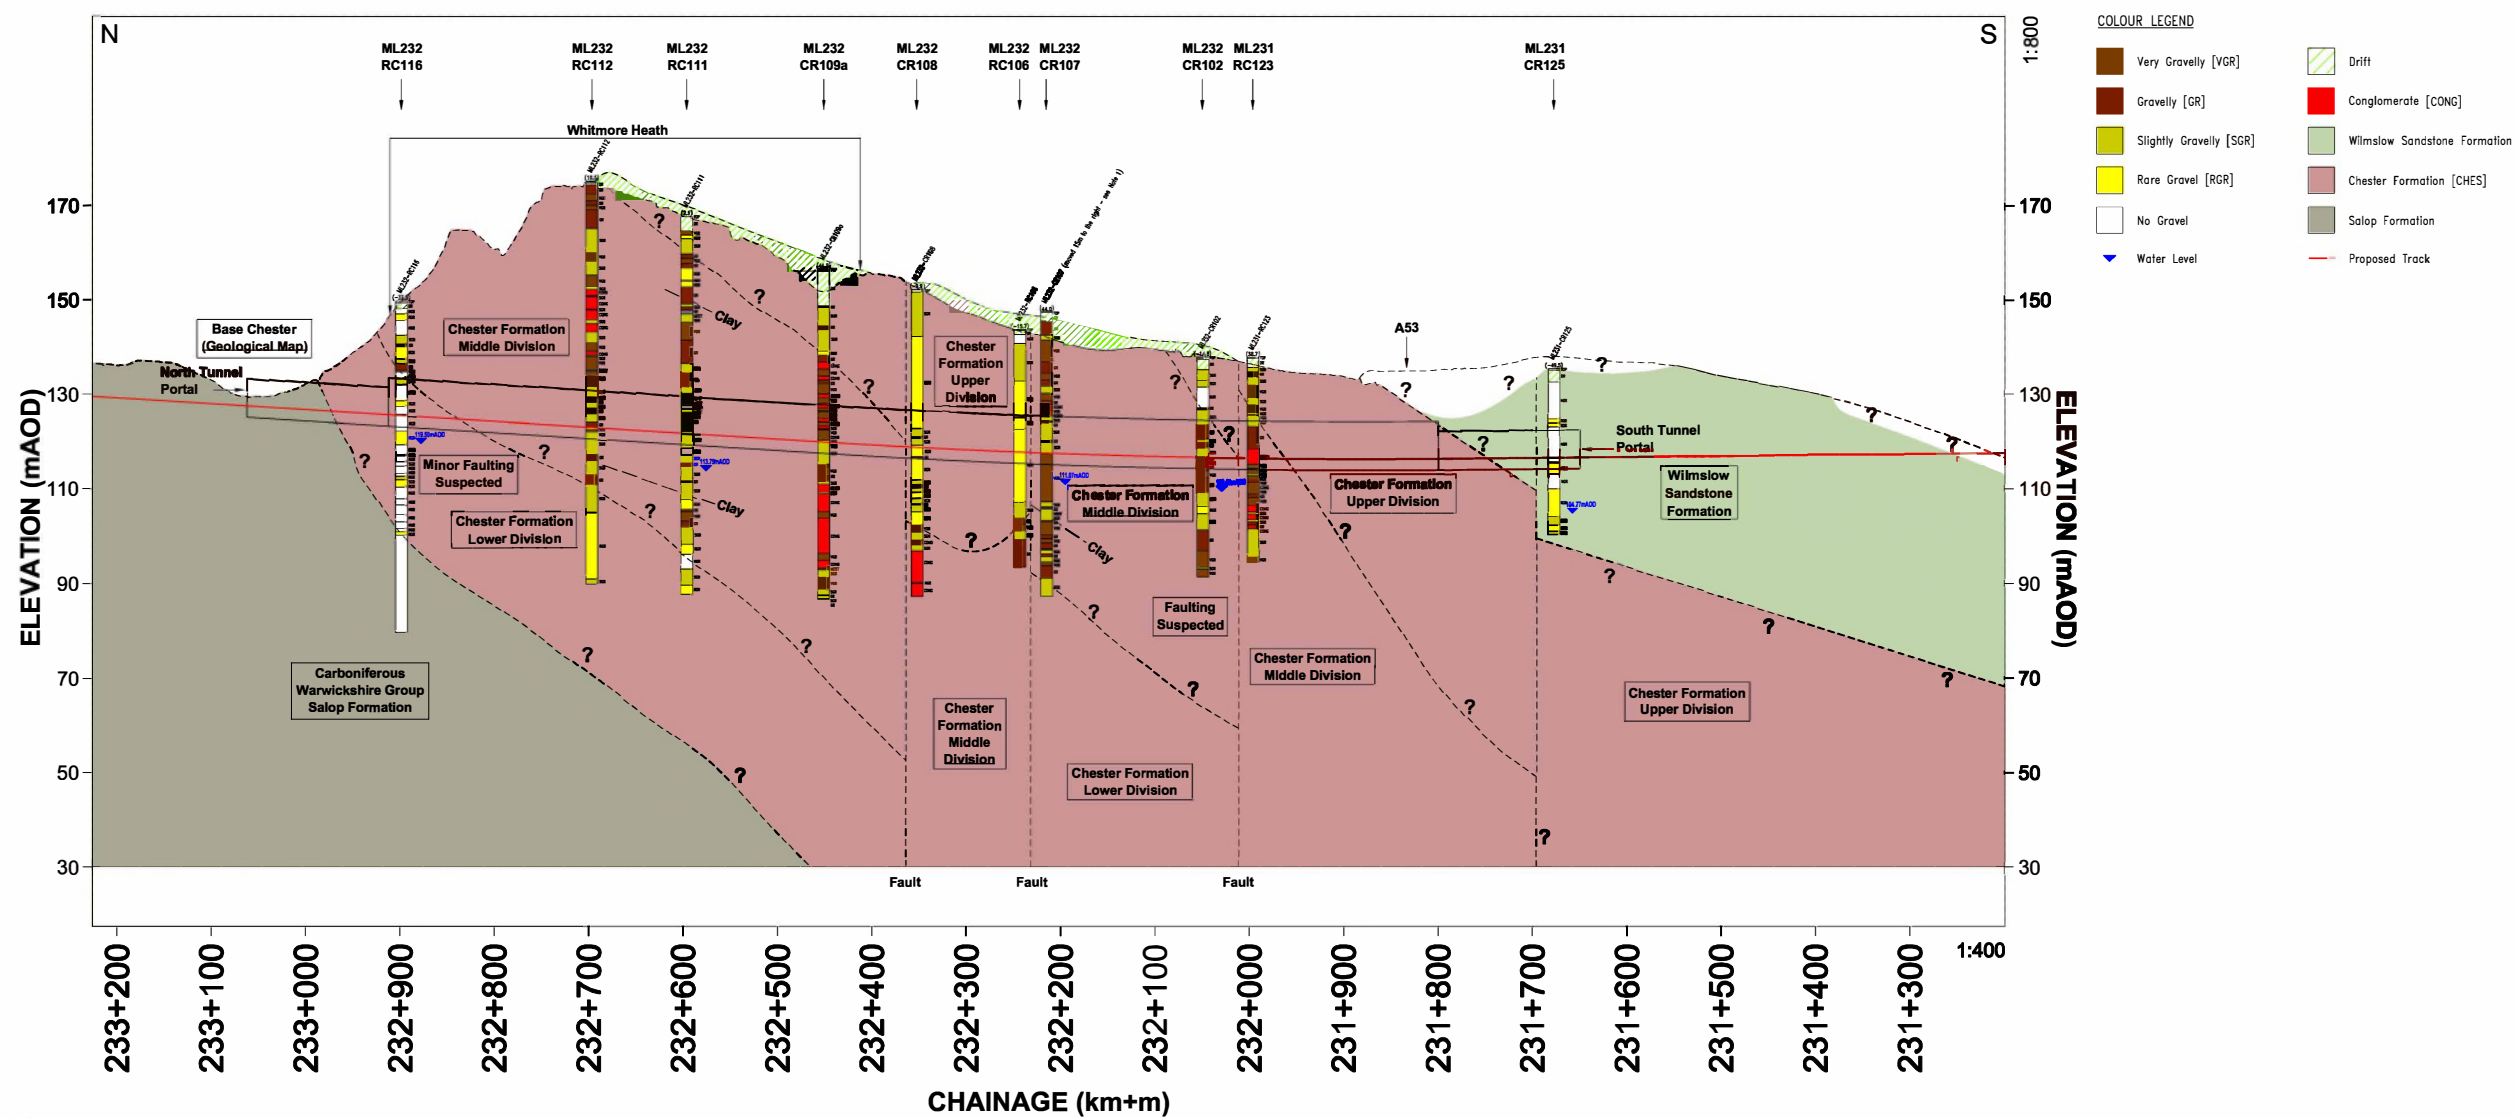
FIGURE 04

- 4.2.1 The geological sequence and ground conditions are generally as anticipated (based on the desk study data). Sandstones, conglomerates and mudstones belonging to the Wilmslow Formation and Chester Formation were encountered from shallow depths. Conditions typically comprise a weathered section of bedrock over extremely weak to weak rock.
- 4.2.2 Shallow superficial deposits encountered were scattered and thin. No significant depths of made ground were encountered.
- 4.2.3 The Whitmore Heath topography, geological and groundwater profile based on the 2018 ground investigation findings (supported by desk study data) and tunnel alignment are shown on the cross section included as Figure 4<sup>1</sup>. Figure 5 shows an

<sup>1</sup> note there is a varying horizontal and vertical scales to the cross section in Figure 4 due to the length of section and the need for clarity of the data reported

- 4.2.5 The Wilmslow Sandstone Formation was encountered in boreholes ML231-RC123 and ML232-CR102, between Chainage 231+700 to 232+250. As shown in Figure 4 this formation underlies the site at ground surface over the southern tunnel portal section to the south of Whitmore Heath. A weathered layer was encountered at the top of the Wilmslow Sandstone Formation. This commonly comprised residual sands and gravels with varying cobble content and occasionally clay was present. The weathered layer was present to a depth of between 6.5 and 11.5 m below ground level.
- 4.2.6 Below the upper weathered zone (6.5-11.5 mbgl), the Wilmslow Formation comprised extremely weak to very weak Sandstone. Mica was frequently present within the sandstone.
- 4.2.7 The base of the Wilmslow Formation was poorly defined.

- 4.2.8 The Chester Formation underlies the Whitmore Heath area at ground surface over the length of the tunnel alignment as shown in Figure 4 and Figure 5. The Chester formation was encountered in boreholes: ML231-RC123, ML232-CR102, ML232-CR106, ML232-CR107, ML232-CR108, ML232-RC111 and ML232-RC112.

- 4.4.1 Both Figures 4 and 5 give a clear illustrative representation of the ground conditions influencing the tunnel assessment. The elevation of the crown ranges between approximately 124 to 134m OD (a minimum of 30m below ground surface) and the invert elevation ranges between 114 to 124m OD, between Chainage 231+800 and Chainage 232+912. The ground conditions encountered across this interval (in boreholes ML232-RC106, ML232-CR107, ML232-RC111 and ML232-RC112) comprise extremely to very weak sandstone and or conglomerate rock from 5-10m below the ground surface to a depth of 20 to 30 m below the invert of the tunnel.

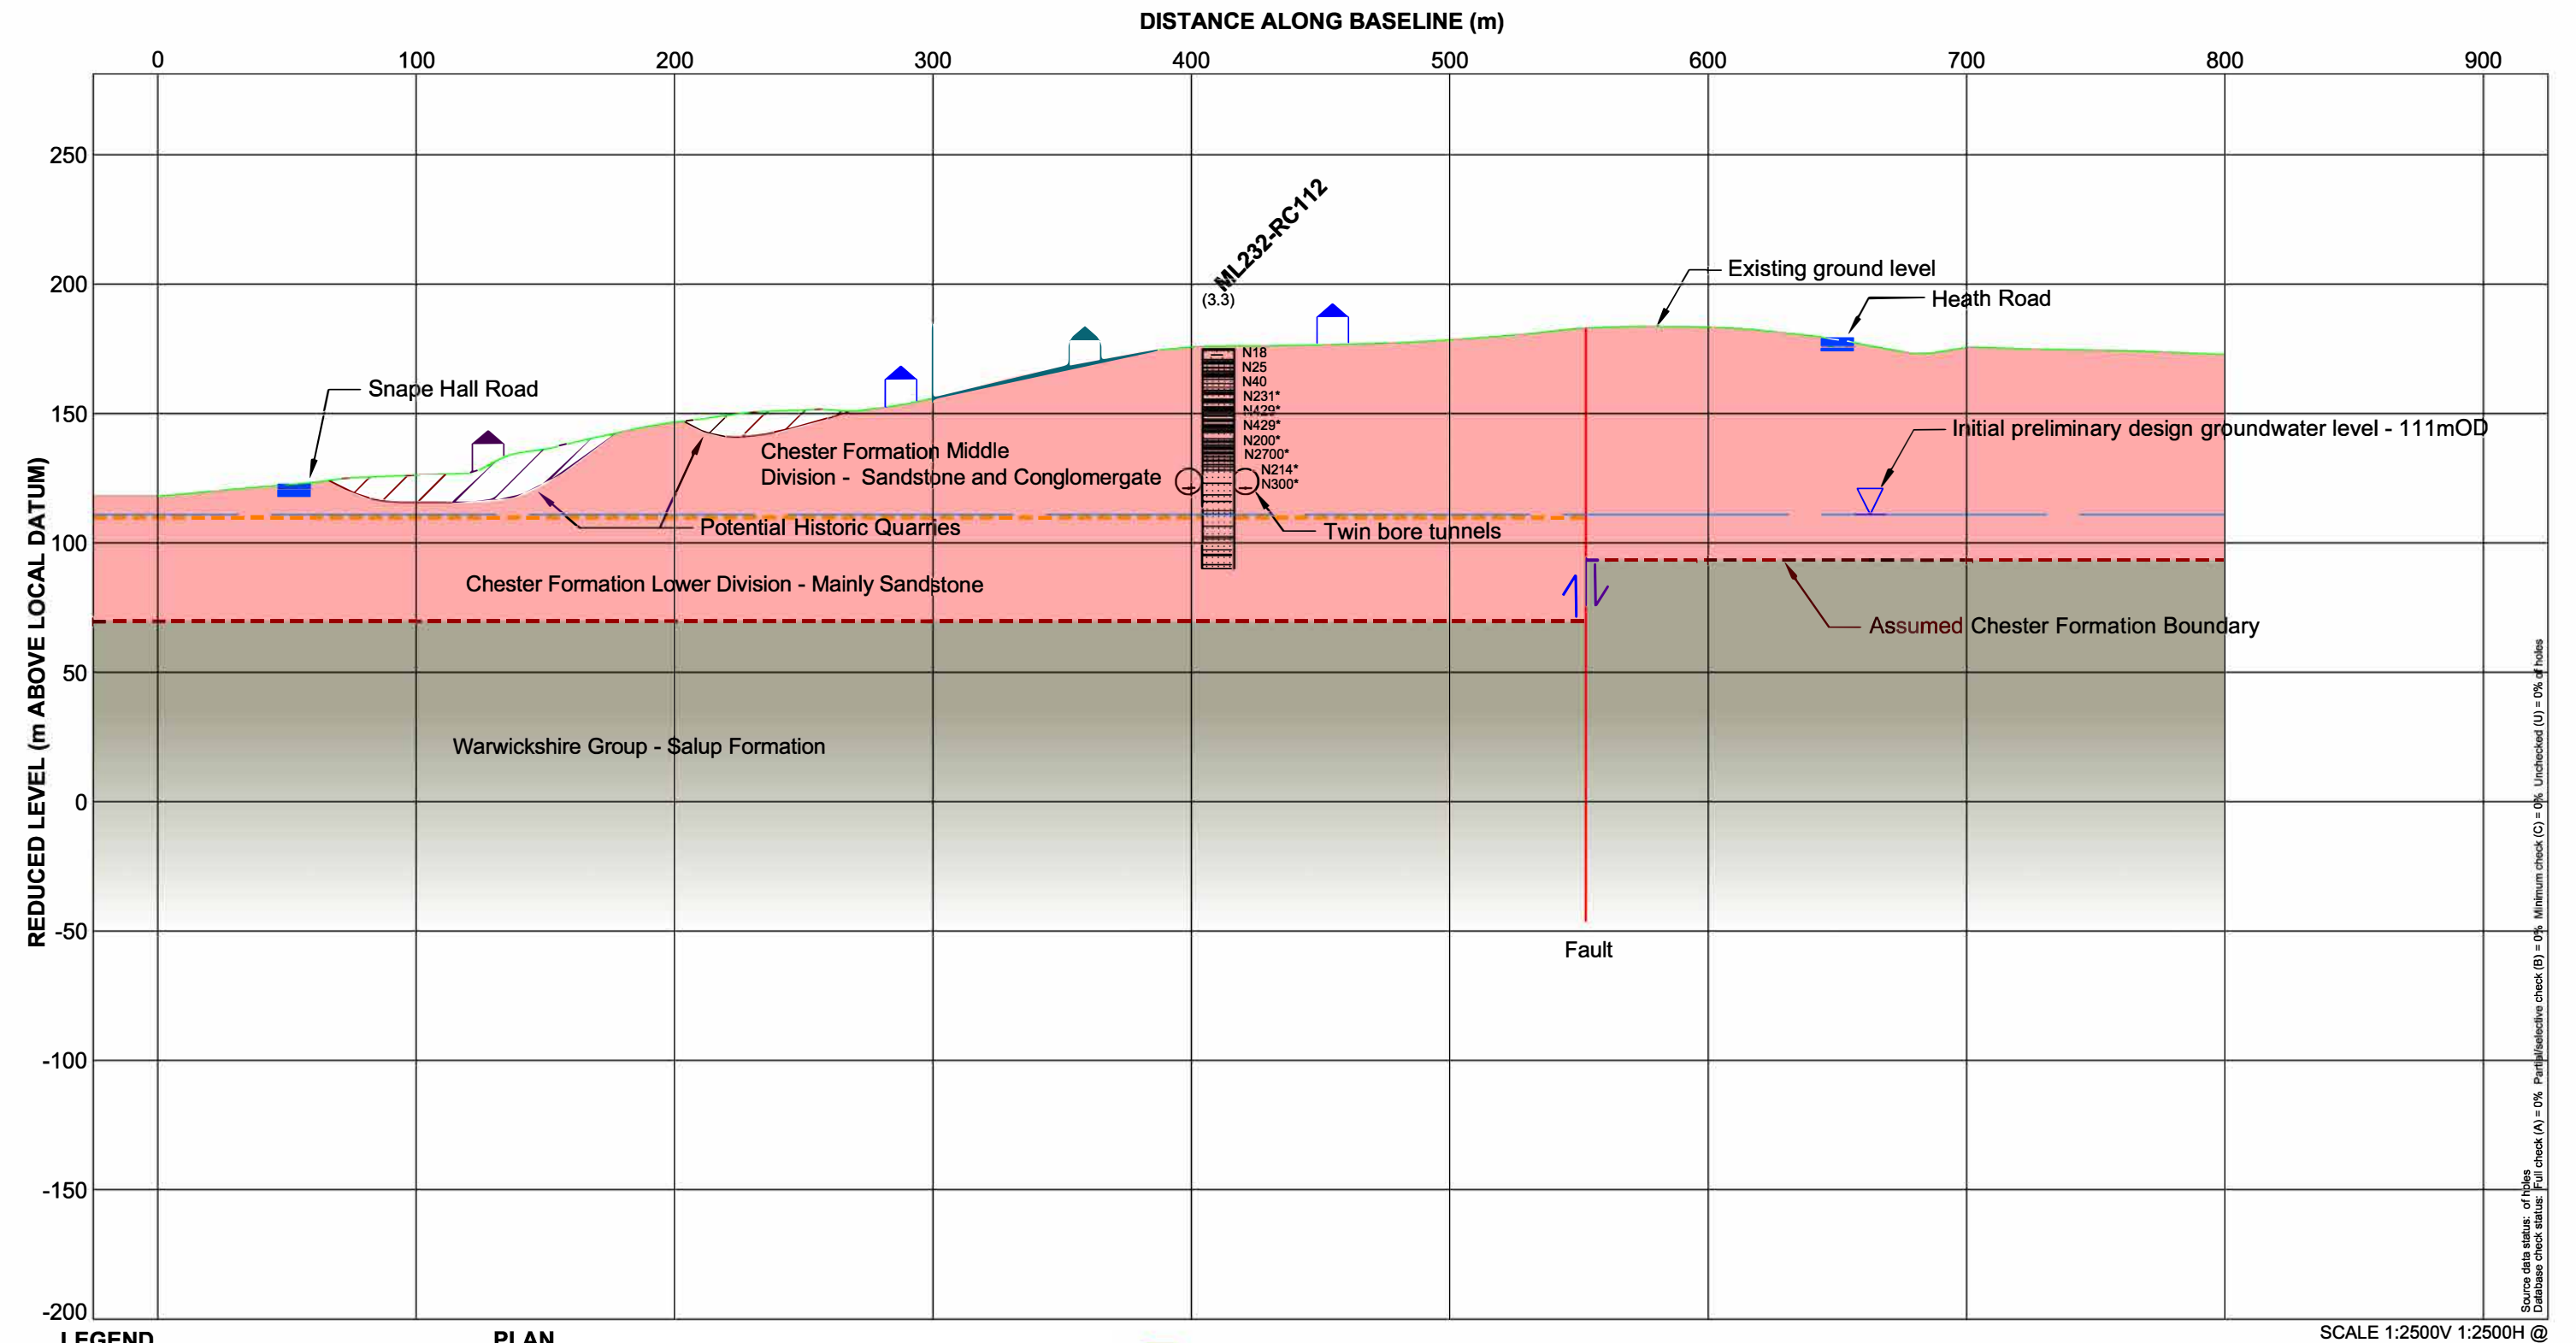
FIGURE 05

illustrative cross section perpendicular to the tunnel across Whitmore Heath. Figure 5 is at the same horizontal and vertical scale and is also therefore representative of illustrative variation in topography west to east and the tunnel in cross section. The ground conditions illustrated on Figure 5 combine Borehole ML232-RC112 with desk based assessed anticipated ground conditions.
